Pipe Condition Survey and Design for Territory-wide Replacement and Rehabilitation of Large Diameter Water Mains in Hong Kong

C K FUNG¹, LEUNG Ming-yuen², and ZHAI Guo-ning³

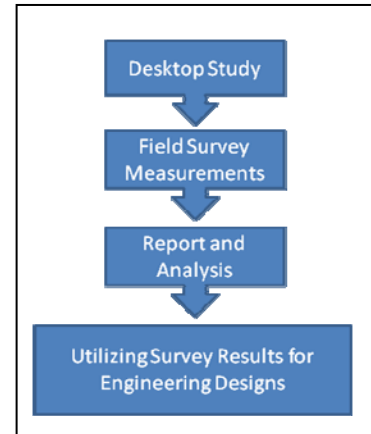
Figure 1: Framework of Pipe Condition Survey Works

The pipe condition survey was conducted based on the framework shown in Figure 1. Desktop study was conducted at the initial stage to review the pipe information. The next stage was to take comprehensive field measurements. As one of the prime concerns for the survey works was to avoid disruption against the normal water supply, non-destructive survey techniques were employed. The field measurement results were then input into the proprietary models *EnviroStat* and *PipeFail* for analysis. The existing conditions of water mains were categorized into five grades, namely “Very Good”, “Good”, “Fair”, “Poor” and “Very Poor” in accordance with the estimated probability of failure. The survey results were used to identify and prioritize the sections of water mains to be replaced or rehabilitated.

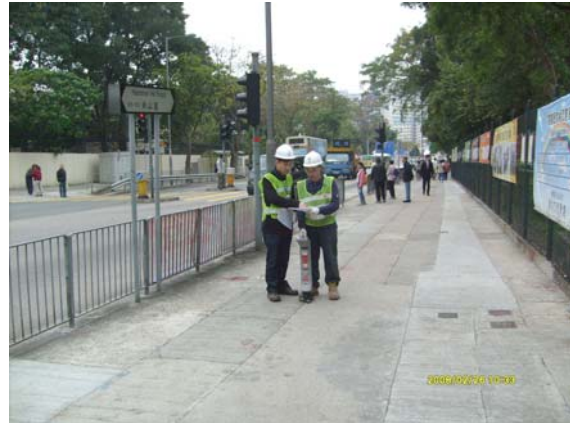
Photo 1: Field Measurement of Coating Defect Survey

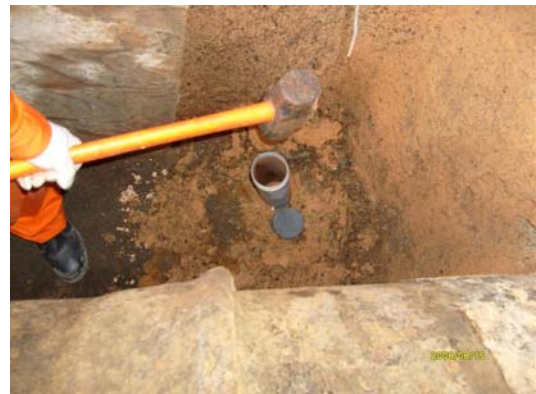
Photo 2: Soil Sample Collected Near Pipeline

A total of 218 numbers of soil samples were collected along the surveyed pipelines to determine the soil corrosivity for the assessment.

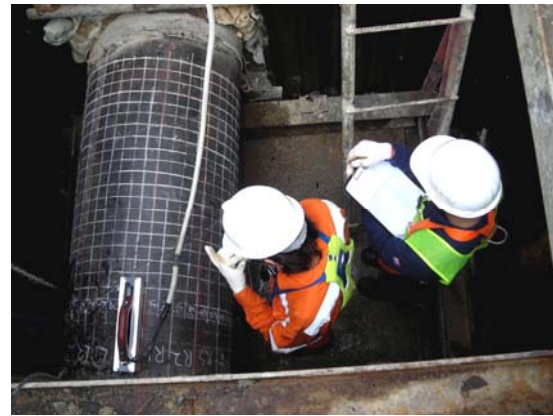
Photo 3: Field Measurement of PWTM

In order to have a better understanding on the pipe joint conditions of the surveyed mains, IUT was carried out to pipe body in vicinity of pipe joints as far as practicable. Magnetic Particle Test (MPT) was also employed to examine the condition of the existing welded joints. In total, 117 numbers of PWTM were carried out and 30 numbers of pipe joints were scrutinized in this project.
